Manhole Inspection Summary

Manhole # S43E__023MH

Insp Date: **6/11/08 8:29 AM**

Location Address: **101 s broadway**

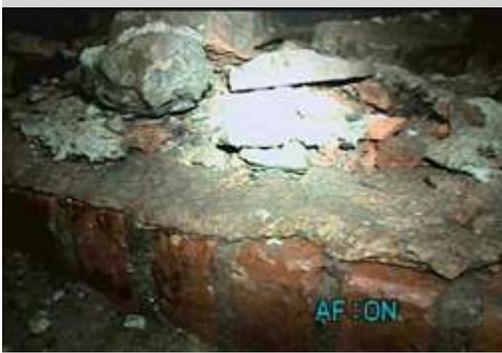
Defect 4

Condition: Sound Cracked Root Intrusion Deteriorated Leaks **Debris**

bench debris

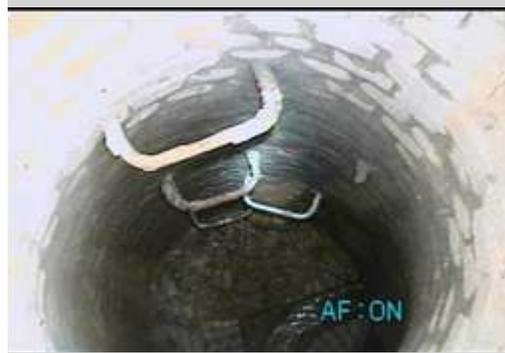
Defect 3

Steps Count: **7** Missing: **2** **Corroded**

corroded steps

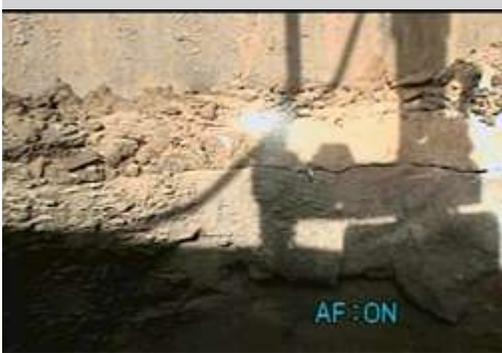
Defect 2

Chimney / Frame Adjustment Exists Material: **Brick and Concrete** Parged Height: **4** (in.)

Condition: Sound **Cracked** Root Intrusion Loose Brick Deteriorated

frame adj

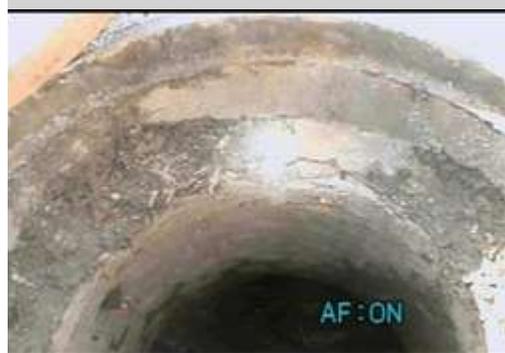
Defect 1

Frame Offset: **4** (in.) Condition: Sound Cracked **Leaks**

frame leaks, offset

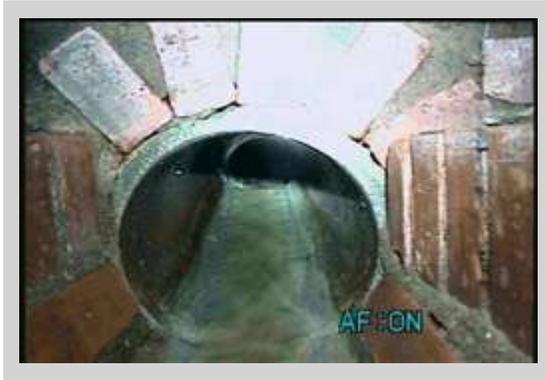
12 O'Clock Outflow

8 in. Circular Gravity Sewer
Pipe Out @ 12 O'Clock

Invert Depth: **12.04** (ft.) Flow Characteristics: **Fast**

Infiltration: **None** Pipe Seal Cond: **Unknown**

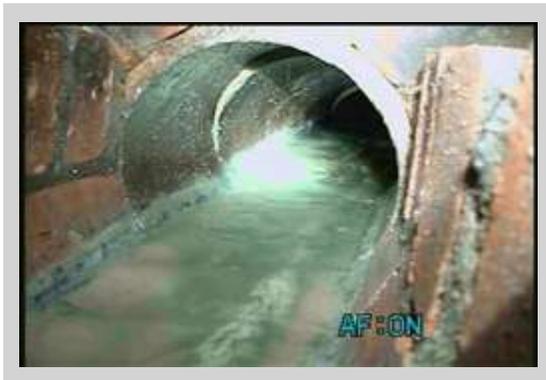
9 O'Clock Inflow

8 in. Circular Gravity Sewer
Pipe In @ 9 O'Clock

Invert Depth: **12.00** (ft.) Flow Characteristics: **Fast**

Infiltration: **None** Pipe Seal Cond: **Unknown**
